Pine Creek Stream Restoration Project Overview

Growing from River to Ridge

History of Pine Creek

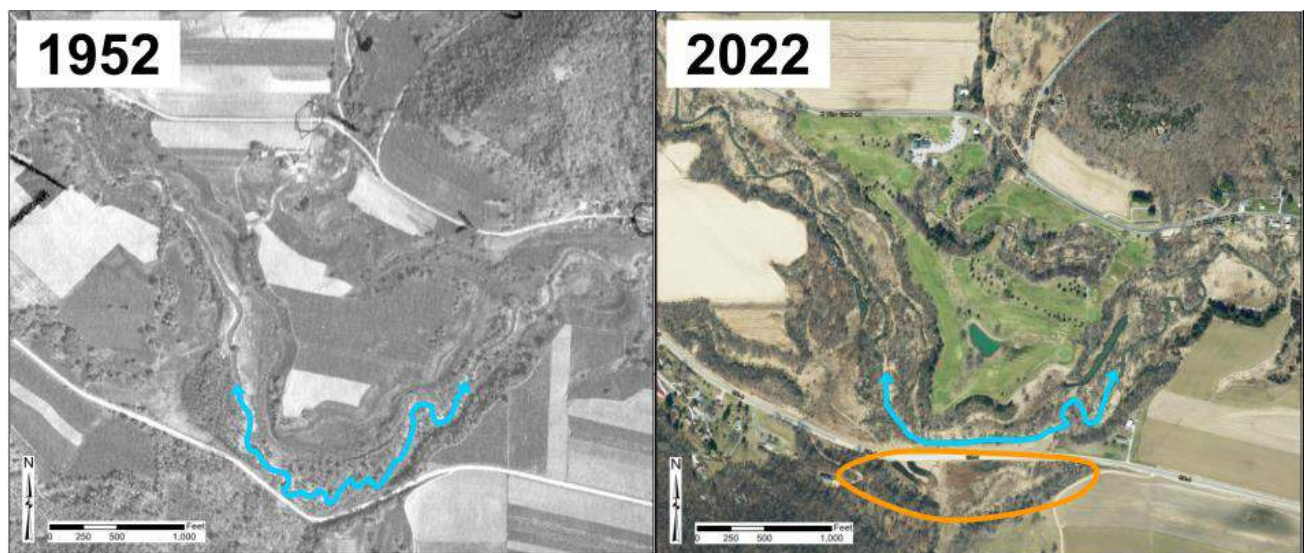
Aerial imagery of Pine Creek restoration site from 1952 (left) and 2022 (right). Blue lines represent the stream's path, highlighting the difference in stream flow following the realignment of County Road 6. The orange circle notes an area in which relics of Pine Creek's previous flow path can be seen.

Pine Creek is DNR-designated public water and a coldwater trout stream. It is located on city-owned property within the La Crescent City Golf Course. In the 1950s, the section of Pine Creek along County Road 6 was straightened for a road realignment project. The difference can be seen between the two images below, one from 1952 and one from 2022. Approximately 700 feet of the stream was lost during that project. Remnants of the previous stream channel are still visible to the south of County Road 6. Today, the stream is lined with box elder trees, which are highly susceptible to damage during windstorms. When trees fall into the stream, they cause log jams and patches of open tree canopy, leading to areas of still, warm water, poor conditions for trout populations. This project will restore up to 2,625 linear feet of the existing stream, while also increasing stream length by 50 feet.

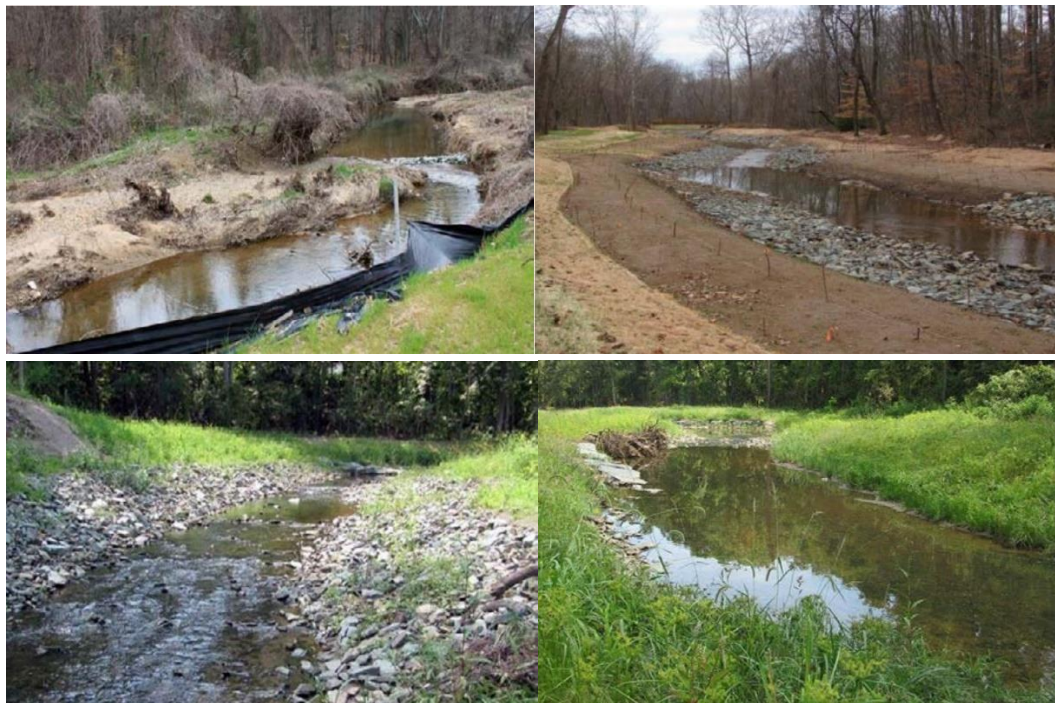
The photos below show the process of reshaping and seeding a stream:

In **Summer 2025**, construction will begin on Pine Creek. The creek and streambanks will be reshaped and stabilized with root wads and toe wood made of existing fallen trees. Reshaping the creek will increase its length by 50 feet. The root wads and toe wood will stabilize the stream channel and prevent further streambank erosion. They will also provide habitat and cover for fish, including trout. Similarly, wetland scrapes along the creek corridor will provide habitat for amphibians, insects, birds, and small mammals. Paths along the creek will be created to allow easy access for recreation.

In **Fall 2025**, the streambanks will be seeded with native seed mixes and native trees will be planted. As the plants become established, their roots will prevent further streambank erosion. Wildlife will benefit from the restoration in the creek and in the surrounding area.

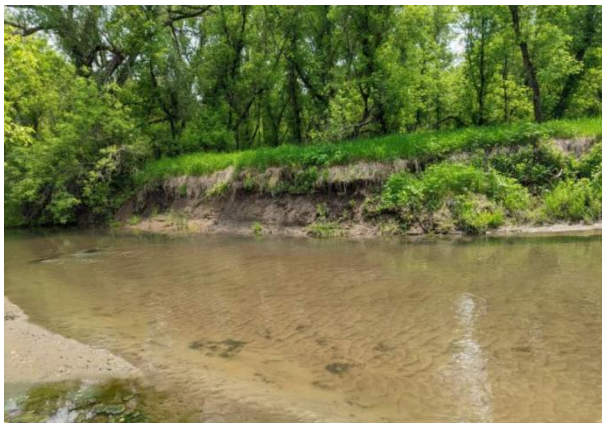
Bank erosion along Pine Creek.

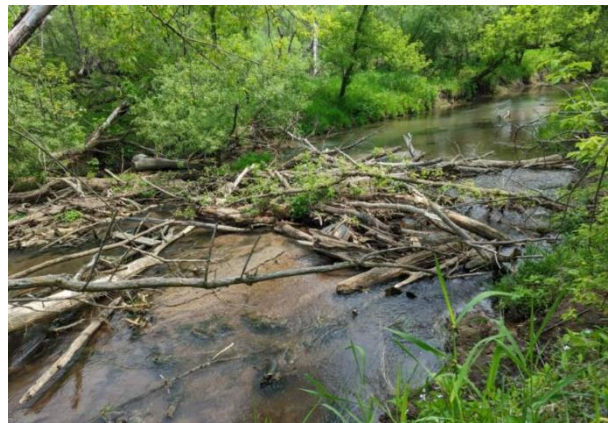
Log jam in Pine Creek.

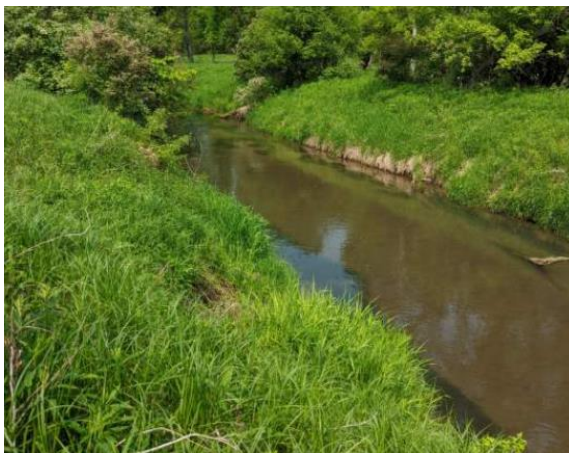
Straightened section of Pine Creek along County Road 6.

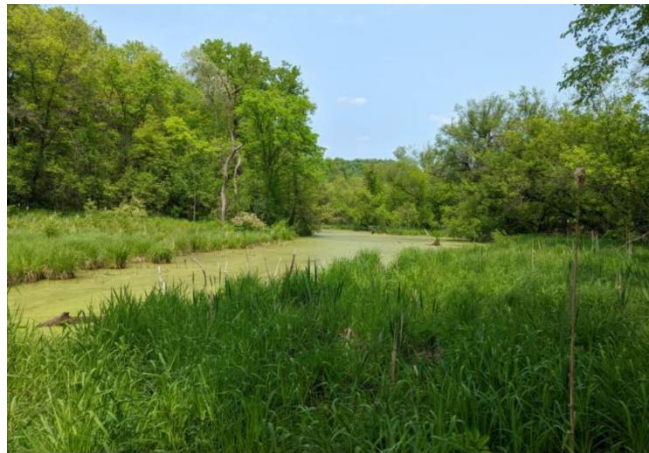
Groundwater fed wetland near Pine Creek.

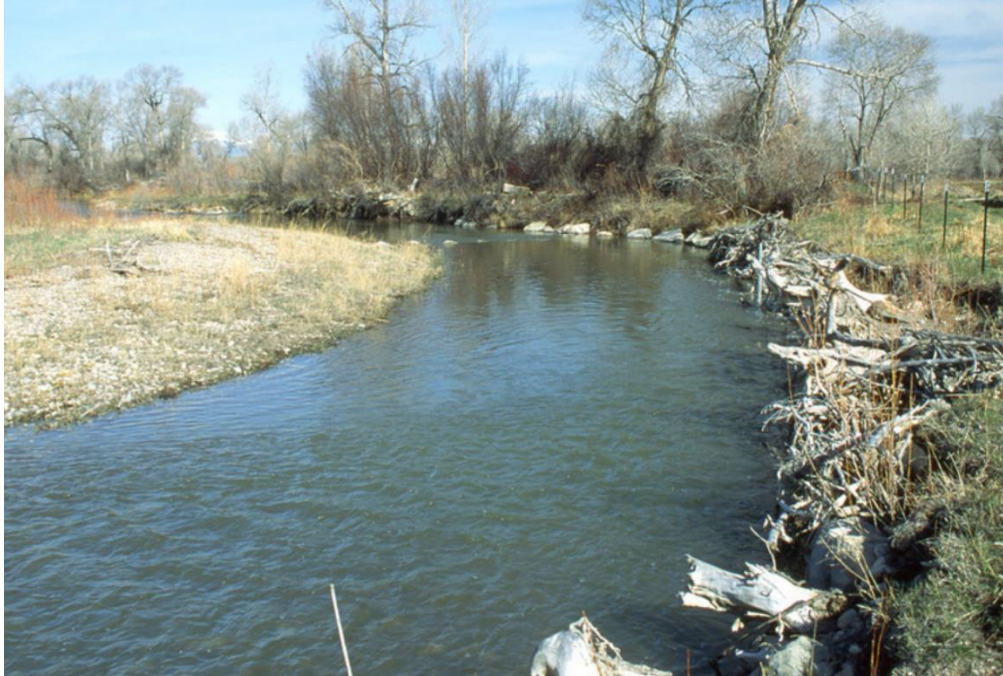
Image 1: Example of root wads along the side of a stream (NRCS).

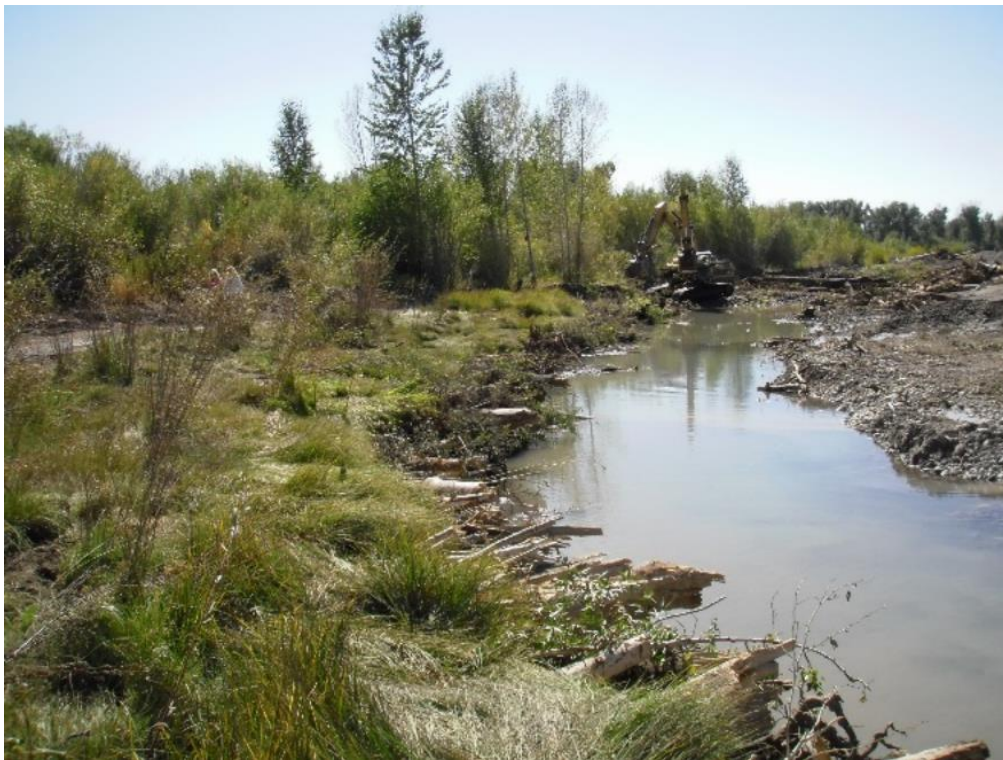
Image 2: Example of toe wood along stream (Wildland Hydrology).
